Watertown Arsenal Laboratory  
Report No. WAL 739/47  
Problem No. R-1.4

### BAYONETS

#### Metallurgical Examination of Six Lots of T2 Bayonets

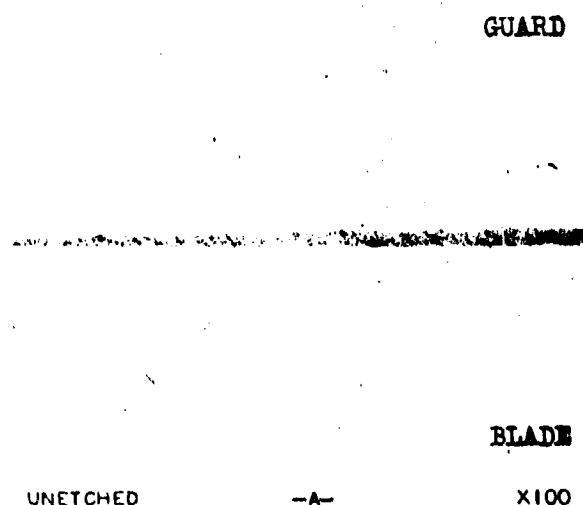
BAYONET F2 JOINT. UNIFORM BRAZE METAL LAYER .001" IN THICKNESS.

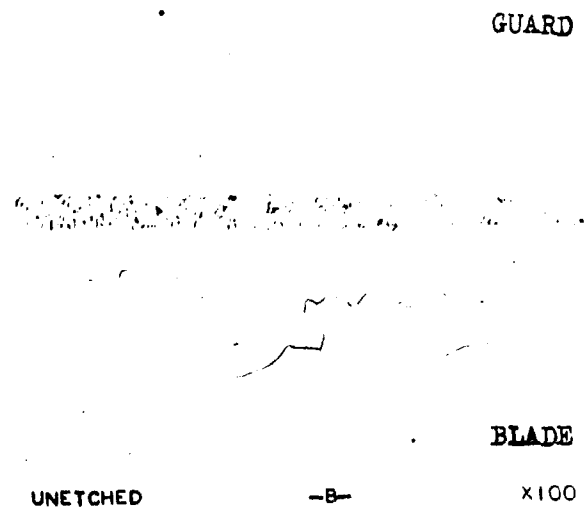
BAYONET E5 JOINT. NETWORK FORM OF BRAZE METAL ON BLADE SIDE. CRACKS PRESENT IN BLADE.

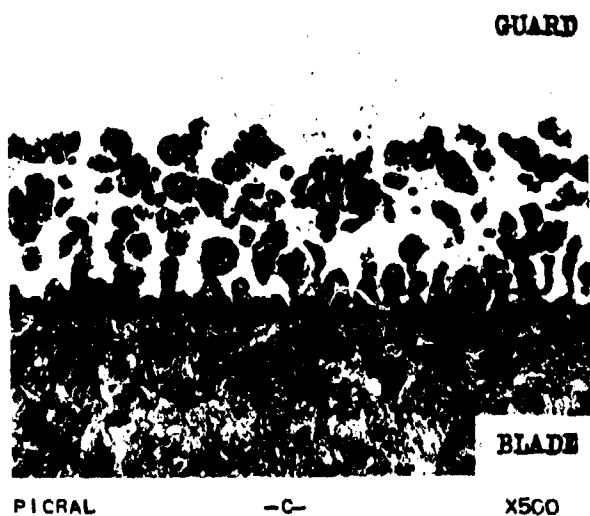
BAYONET E5 JOINT. PENETRATION OF BRAZE METAL ALONG GRAIN BOUNDARIES OF BLADE.

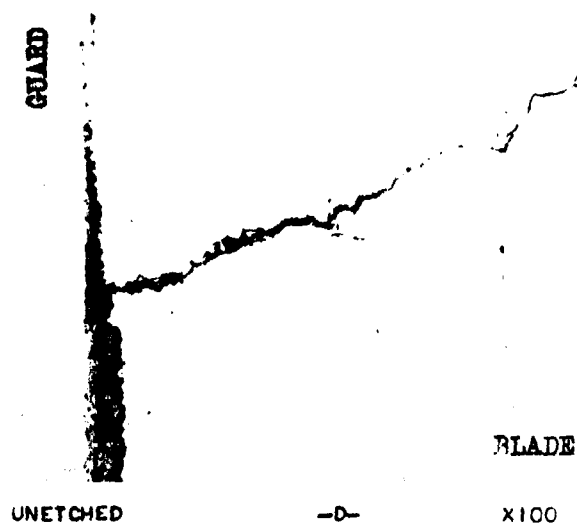
BAYONET E5 JOINT. CRACK FILLED WITH BRAZE METAL EXTENDS .026" IN BLADE.
